Share Deficiency Cases in Belgium/Netherlands

(Updated on 2023.05.12)

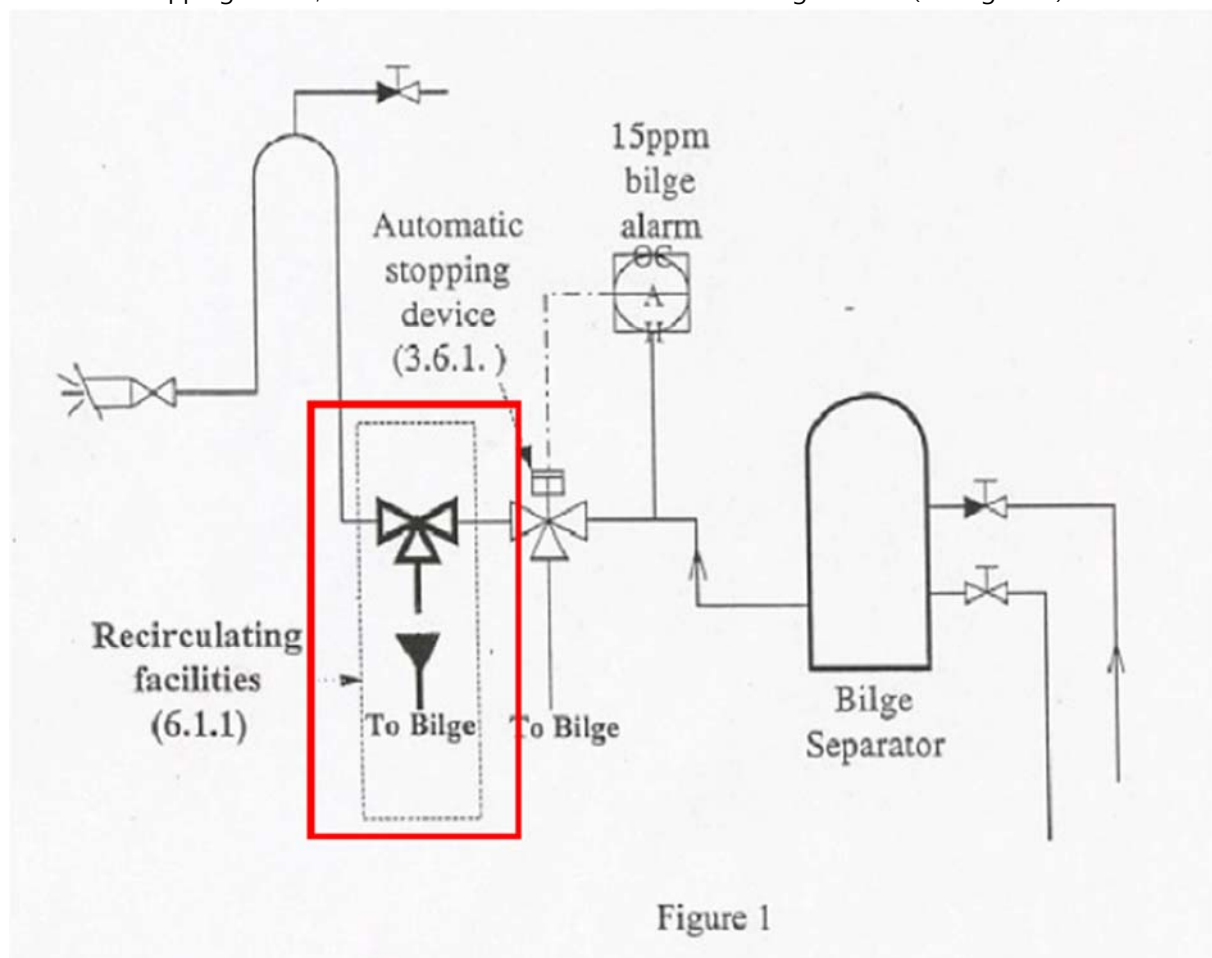
Figure 1

The filtering equipment (piping) is not installed compliant to MEPC 107. At 3-way valve outlet OWS to overboard/ return to bilge tank. On the line to bilge tank (recirculation facilities 6.1.1) there is no funnel or sight glass provided to observe full opening or closure of the automatic 3-way valve (automatic stopping device 3.6.1) behind the OWS. Ch. Eng Stated the company already is investigating the lay out by installing a sample valve/Line. This is not correct as the interruption of the flow is to be verified. [QUOTE MEPC.107(49)]

6.1.1 For future inspection purposes on board ship, a sampling point should be provided in a vertical section of the water effluent piping as close as is practicable to the 15 ppm Bilge Separator outlet. Re-circulating facilities should be provided, after and adjacent to the overboard outlet of the stopping device to enable the 15 ppm Bilge Separator system, including the 15 ppm Bilge Alarm and the automatic stopping device, to be tested with the overboard discharge closed (see figure 1).
