Information of PSC Issue

Issue date : 14 June 2024

Subject: Implementation Plan for Enhanced Inspections of Engine Room Emergency Escape Trunk by China MSA

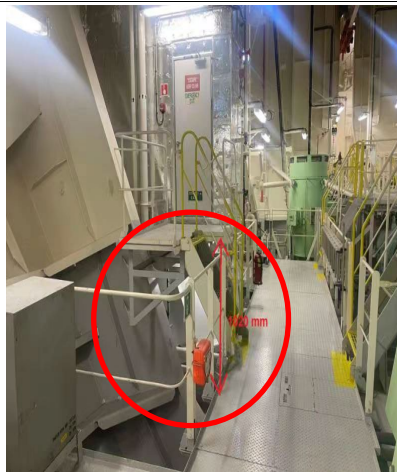
Pass

Escape Trunk Positioned at the lowest possible due to the vessel's structure

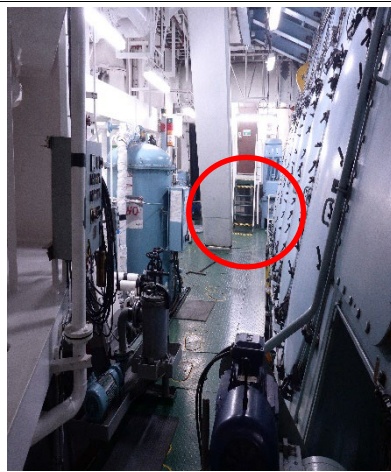
Pass

Escape Trunk Positioned at the lowest possible due to the vessel's pipings

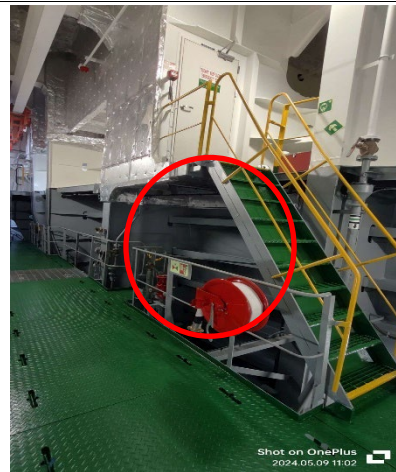
Fail

The Escape Trunk is positioned on a higher platform, despite there being no interference from structures or piping. The trunk could have been extended to a lower position to comply with safety regulations.
