## Marine Investigation Preliminary Report

# Contact of Containership *Dali* with the Francis Scott Key Bridge and Subsequent Bridge Collapse

<b>Location:</b>	Baltimore, Maryland	<b>Accident Number:</b>	DCA24MM031
<b>Date and Time:</b>	March 26, 2024 0129 local time (eastern daylight time)	<b>IMO Number:</b>	9697428
<b>Ship:</b>	<i>Dali</i> (Neo-Panamax containership)	<b>Injuries:</b>	8 (6 fatal)

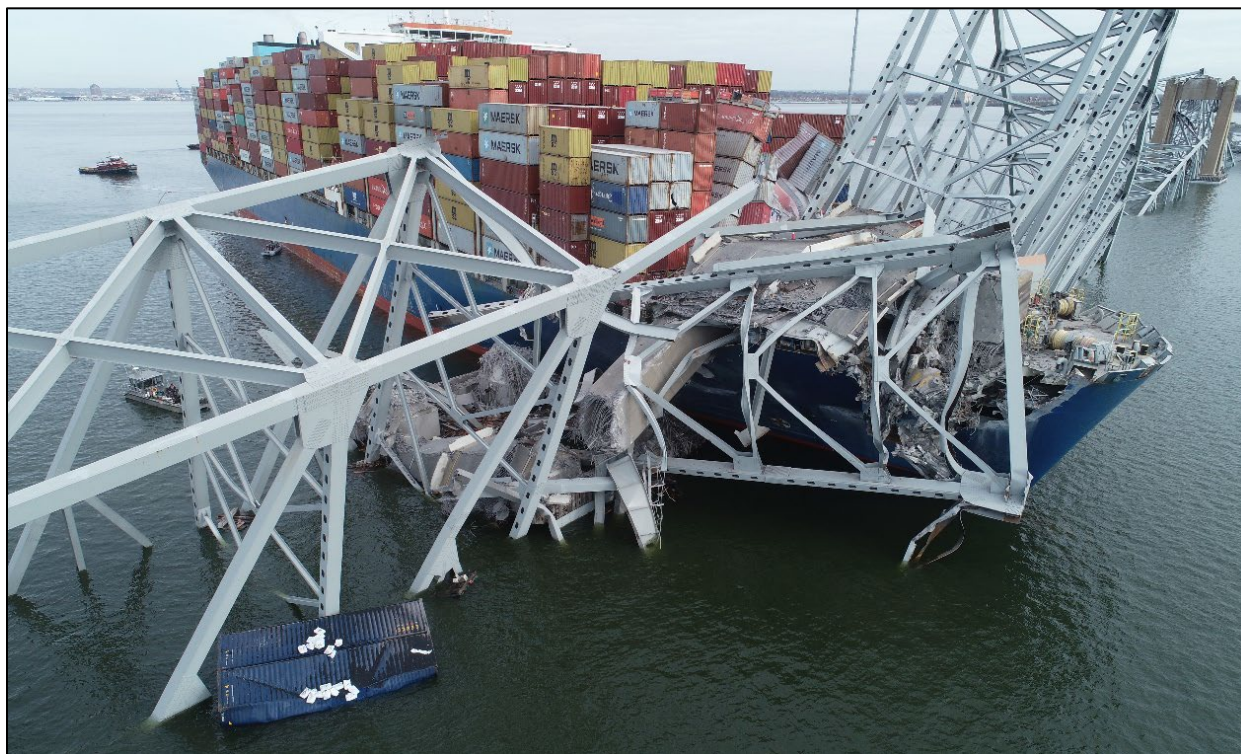
**Figure 1.** The *Dali*, with portions of the collapsed Key Bridge across its forward deck and in the Patapsco River, on March 28.

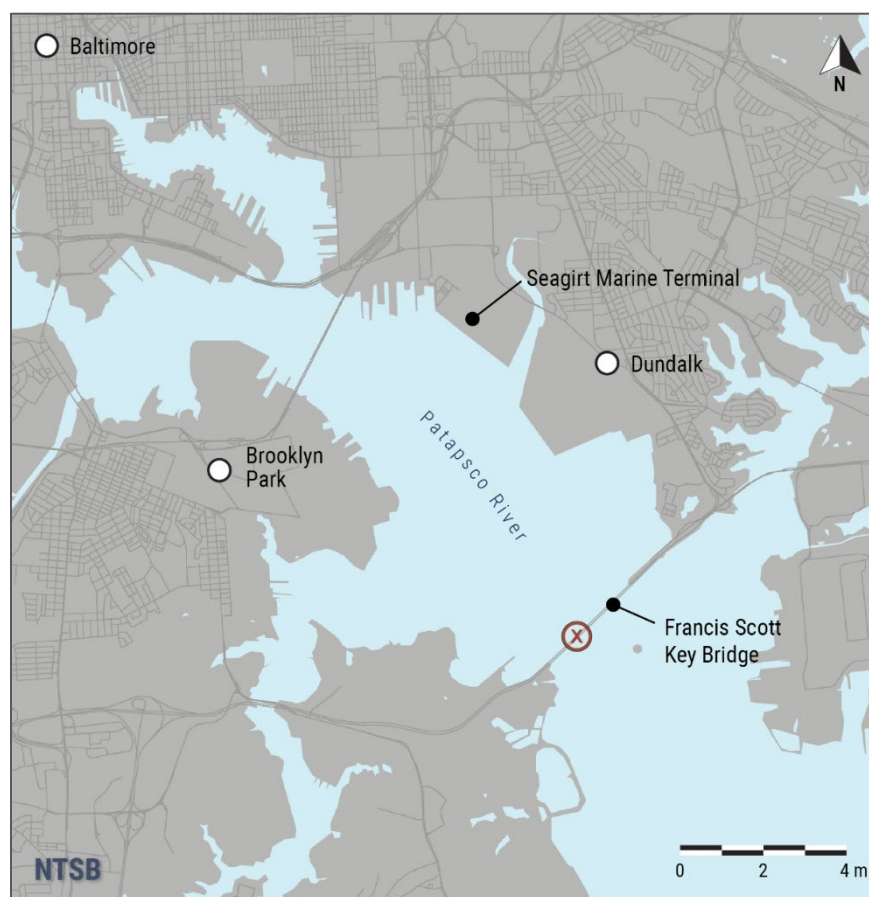
**Figure 4.** Area where the *Dali* struck the Key Bridge, as indicated by the red X. (Background source: Google Maps)

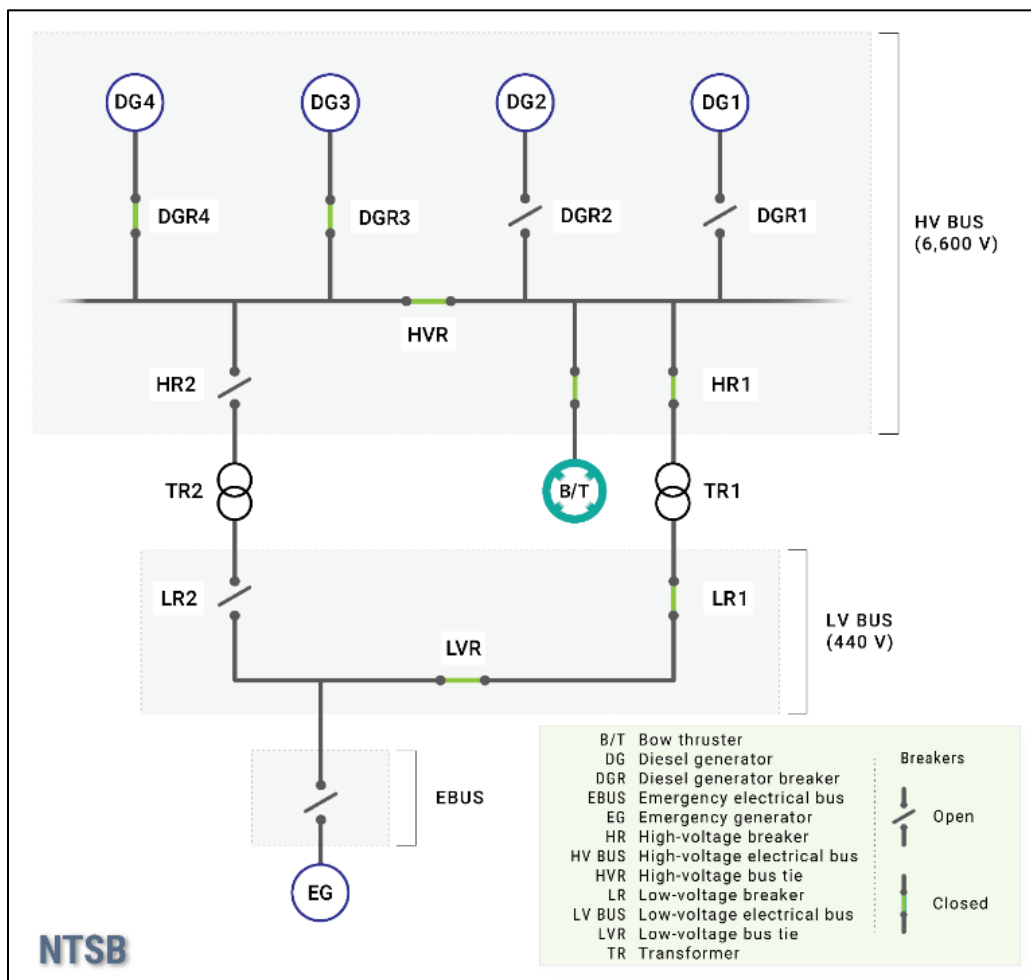
**Figure 5.** Simplified one-line electrical diagram of the *Dali* electrical power distribution system. Breakers shown reflect their positions at departure on March 26.

About 0125, the *Dali* was 0.6 miles—or three ship lengths—from the Key Bridge when electrical breakers (HR1 and LR1) that fed most of the vessel's equipment and lighting unexpectedly opened (tripped) (see figure 7). This caused the first blackout (loss of electrical power) to all shipboard lighting and most equipment, including the main engine cooling water pumps (which controlled engine cooling water pressure) and steering gear pumps.

- The *Dali* crew was able to restore electrical power to the vessel, but, when the ship was 0.2 miles from the bridge, a second electrical blackout occurred because DGR3 and DGR4, the breakers that connected generator nos. 3 and 4 to the HV bus, opened, causing a total loss of vessel electrical power (HV bus and LV bus). Having connected to the emergency bus by this time, the emergency generator provided electrical power to the emergency equipment continuously through the second electrical blackout.
- Generator no. 2, which had previously started automatically because it was in standby mode, connected and restored power to the HV bus via DGR2.

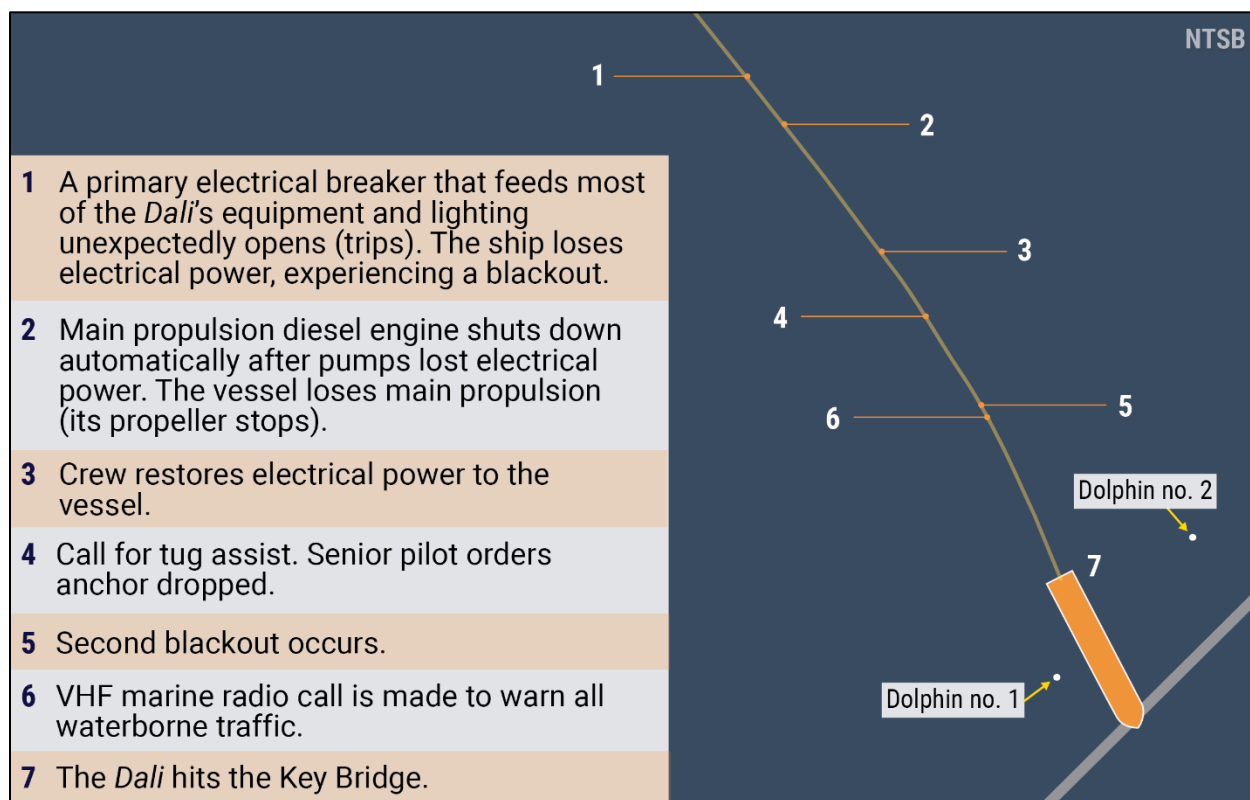
**Figure 7.** The *Dali*'s route on March 26, between the first blackout, and the *Dali* striking pier no. 17 of the Key Bridge. The location and approximate size of two of the bridge's "dolphins," sheet pile and concrete structures protecting the bridge's piers, are labeled in the lower right.

At 0129:10, the *Dali*'s starboard bow struck pier no. 17 of the Key Bridge at 6.5 knots. Six spans of the bridge (the main spans [17, 18, and 19] and spans 20, 21, and 22) subsequently collapsed into the water and across the ship's bow. A *Dali* crewmember, who was on the bow at the time of the accident, told investigators that, as he was releasing the brake on the port anchor, he had to escape from the falling bridge before he was able to reapply the brake. (Due to ongoing salvage efforts, the amount of anchor chain paid out is still unknown.)

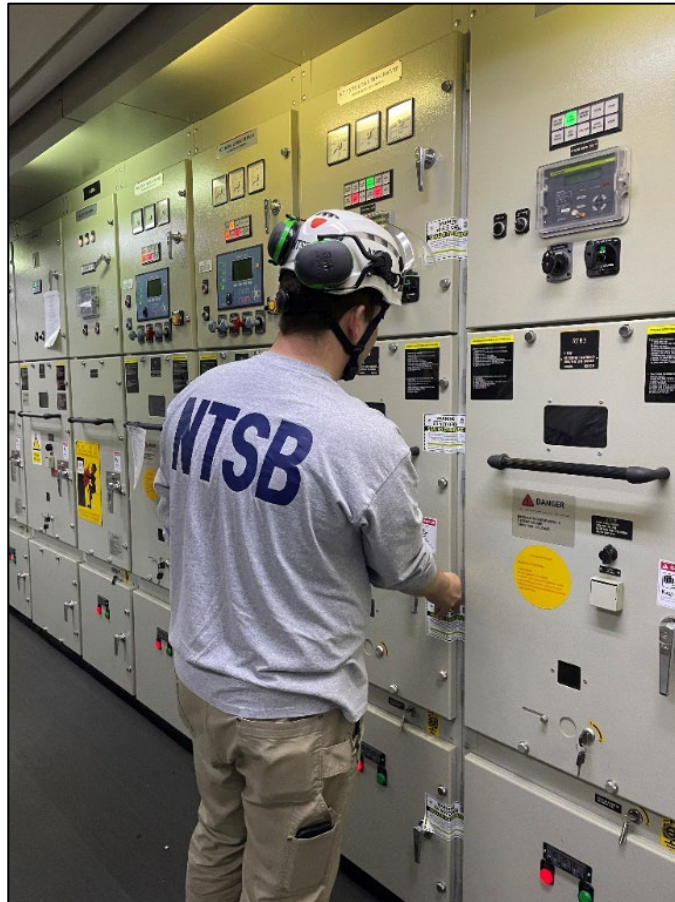
**Figure 8.** An NTSB investigator examining the *Dali*'s HV switchboard (which houses the HV bus) and applying tamper-evident preservation seals.

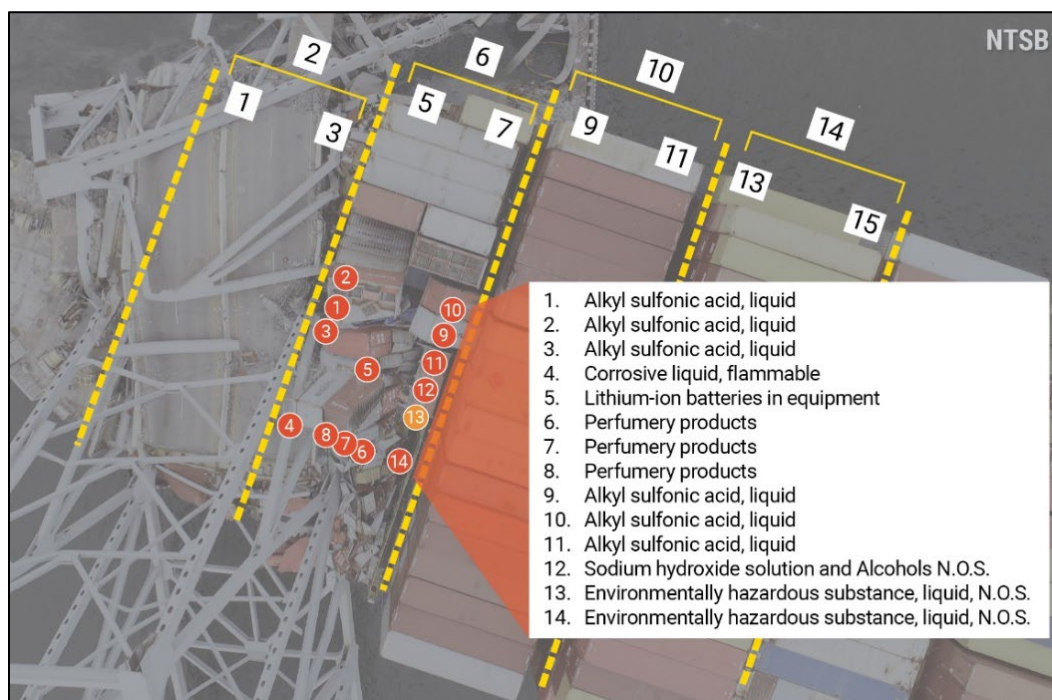
**Figure 9.** Approximate locations of cargo bays (yellow with numbers in white squares) and the 14 impacted hazardous materials shipping containers (orange circles with white numbers) transposed onto the *Dali* as seen after the accident. Hazardous material container no. 13 was in a portable tank, stored in the hold, below the deck.

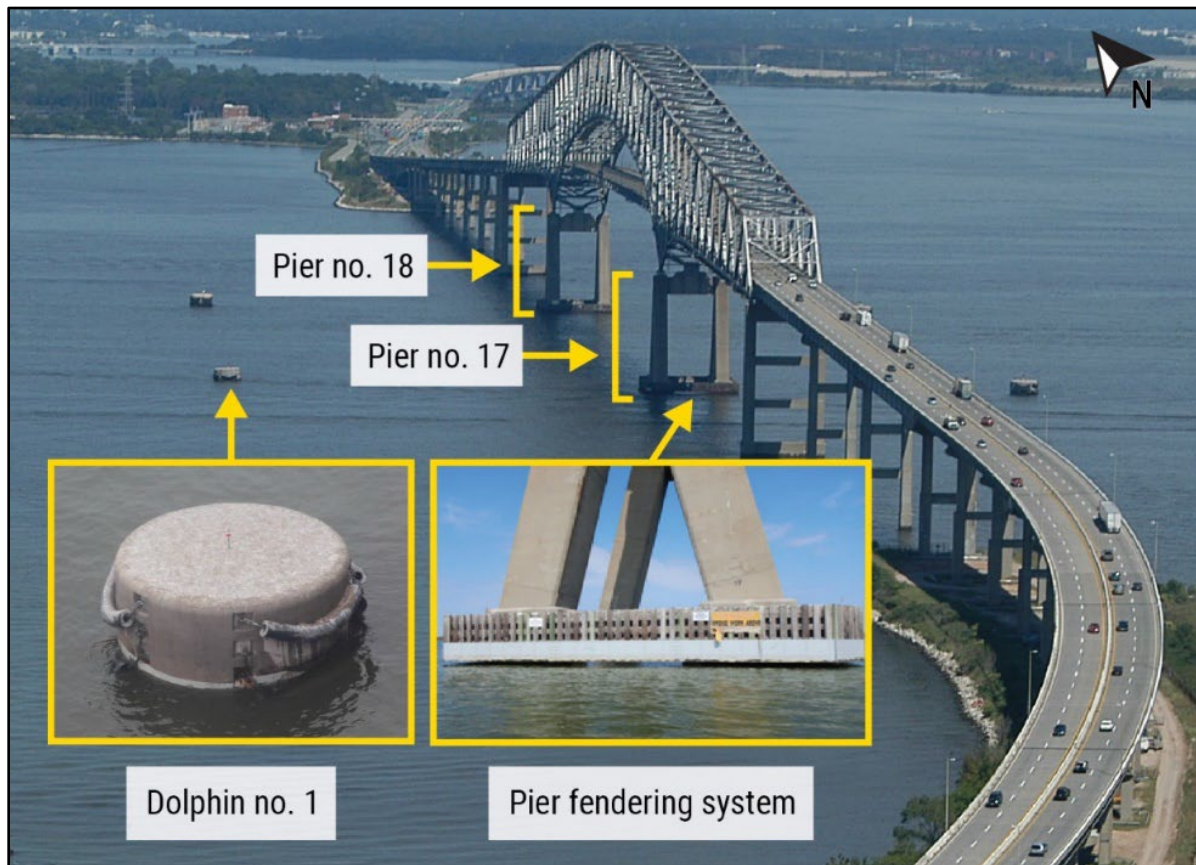
**Figure 12.** The Key Bridge and the locations of pier nos. 17 and 18. Insets show dolphin no. 1 as well as pier no. 17's fendering-system surrounding. (Background source: MDTA)

In addition to the dolphins, pier nos. 17 and 18 were each surrounded by a 100-foot-by-84.5-foot crushable concrete box and timber fender system, as seen in figure 12. These systems were comprised of hollow, thin-walled, concrete box structures attached to the piers. The timber portions of the fender were attached to the outer face of the concrete box and utilized a combination of vertical and horizontal members. Additionally, steel plates were secured at the base of the vertical timber members.

The *Dali* struck pier no. 17 and the fendering system surrounding the pier but did not contact dolphin no. 1 or its rubber fenders. Both fendering systems surrounding pier nos. 17 and 18 were further damaged during the collapse of the truss spans of the bridge when components of the truss spans impacted portions of the fenders as the components fell into the water.
