## Marine Investigation Preliminary Report

# Contact of Containership *Dali* with the Francis Scott Key Bridge and Subsequent Bridge Collapse

<b>Location:</b>	Baltimore, Maryland	<b>Accident Number:</b>	DCA24MM031
<b>Date and Time:</b>	March 26, 2024 0129 local time (eastern daylight time)	<b>IMO Number:</b>	9697428
<b>Ship:</b>	<i>Dali</i> (Neo-Panamax containership)	<b>Injuries:</b>	8 (6 fatal)

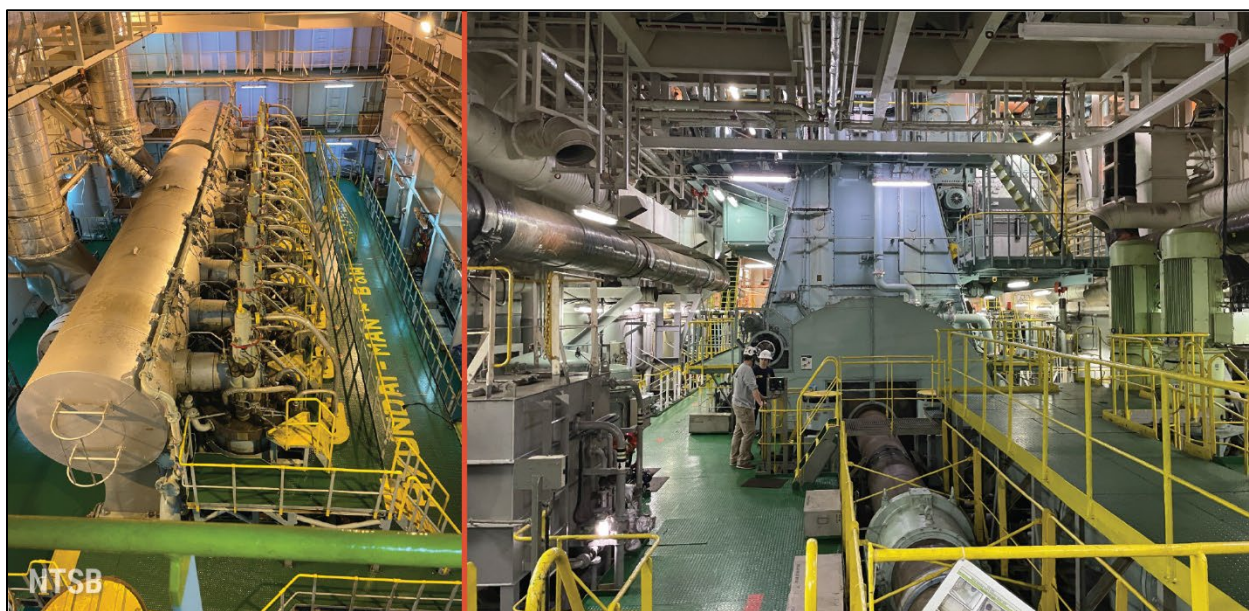
**Figure 2.** Left: The *Dali*'s main engine room (looking aft), showing the vessel's engine. Right: NTSB investigators examining the lower level of the vessel's engine room (looking forward).

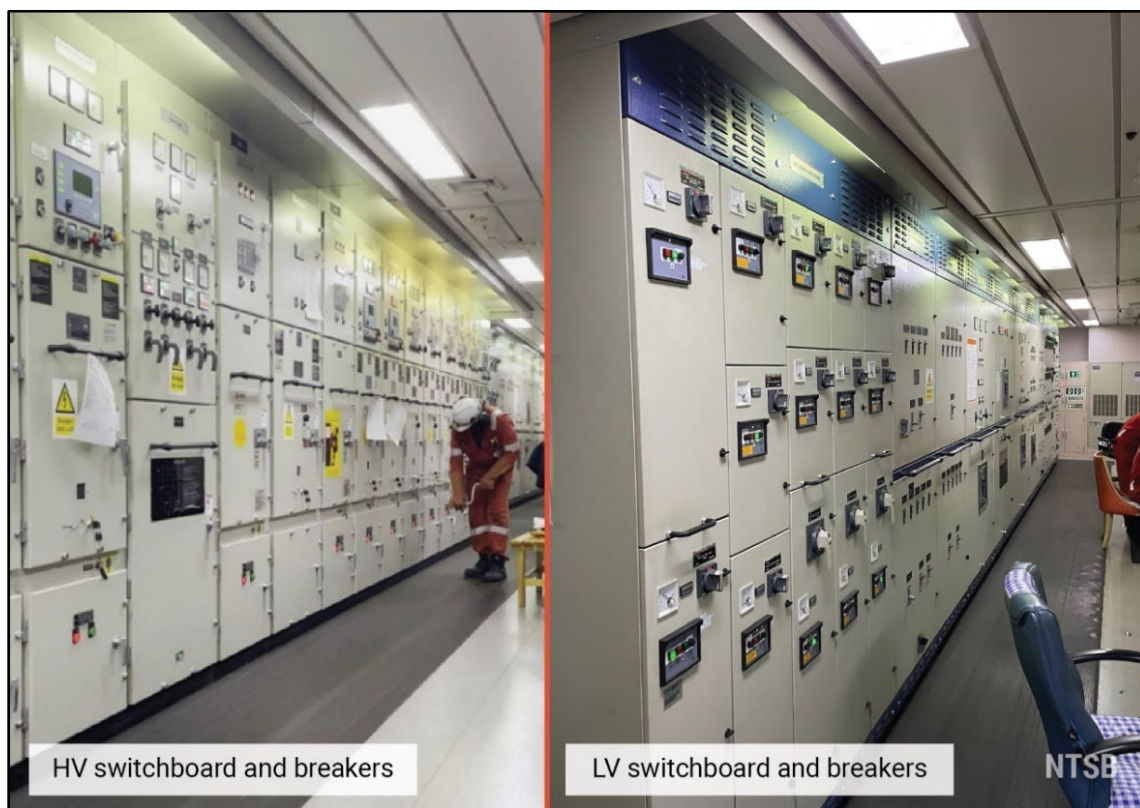
**Figure 3.** The *Dali*'s power management system in the ship's engine control room. The HV switchboard (which houses the HV bus) and breakers (*left*) and the LV switchboard (which houses the LV bus) and breakers (*right*).

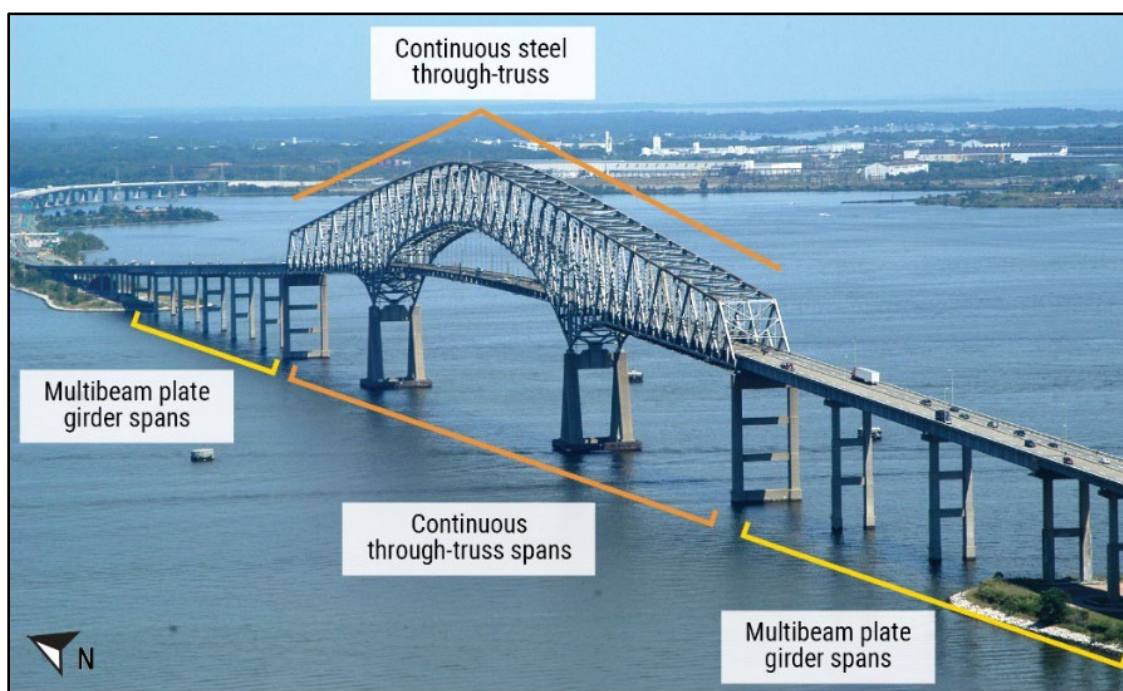
**Figure 10.** The Key Bridge with its truss and spans labeled. (Background source: MDTA)

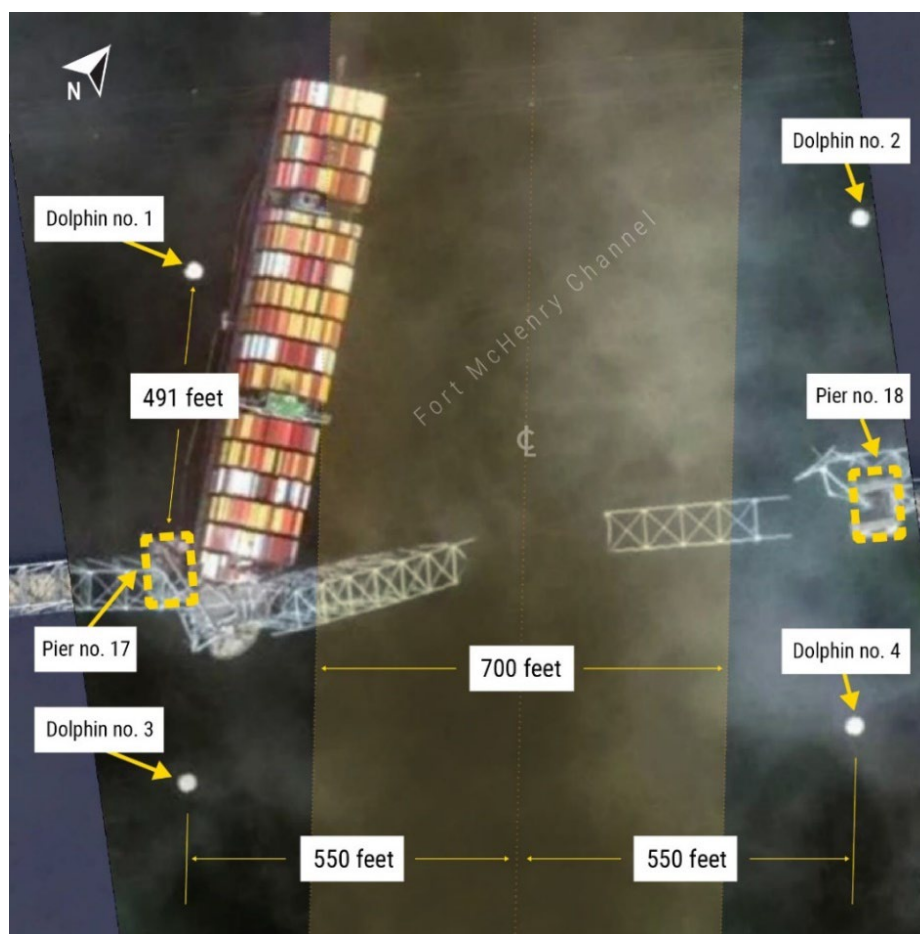
When the Key Bridge was constructed, four large dolphins—two located on the west side of the bridge and two located on the east side of the bridge—were also constructed at the same time to protect pier nos. 17 and 18 supporting the bridge's central through-truss spans. Dolphin no. 1 was about 491 feet west of the center of pier no. 17 and 550 feet clear of the centerline of the navigational channel (see figure 11). The dolphins were constructed with a 25-foot-diameter sheet pile filled with tremie concrete and capped with reinforced concrete (see figure 12). Attached at various locations on the dolphin were 17-foot-long rubber fenders.

**Figure 11.** Locations of dolphins relative to the *Dali*, the Key Bridge, and Fort McHenry Channel. (Background sources: MAXAR and Google Earth)
